SAFETY ALERT

Fugro Company:	Fugro Peninsular
Location/Site:	M10 / M11, Red Line South Metro, Doha, Qatar
Date and Time:	19 th June 2014 05:30
Consequences:	Equipment damage
Incident Potential	High <input checked="" type="checkbox"/> Medium <input type="checkbox"/> Low <input type="checkbox"/>
Incident Description	<p>On 19th June 2014 at 0530 on the Red Line South Metro project in Doha a Fugro Peninsular drill crew commenced with tripping out PQ rods from a 25m completed borehole, (borehole was completed previous evening and intended for instrument installation).</p> <p>The drill crew tripped out the first length of drill string manually, using stilson spanners. The crew removed the rod (3m length) and then ran the head back down. The crew engaged the string again. During this activity they found that the casing string was stuck, and would not trip upwards.</p> <p>To attempt to release the stuck casing the driller replaced the 3m casing drill rod and reengaged the string. During this process the driller left his control panel to assist his helpers with lining up the joint in the bottom clamps. The F100 drill rig started to lift on the string and as a result of this the rig tipped o

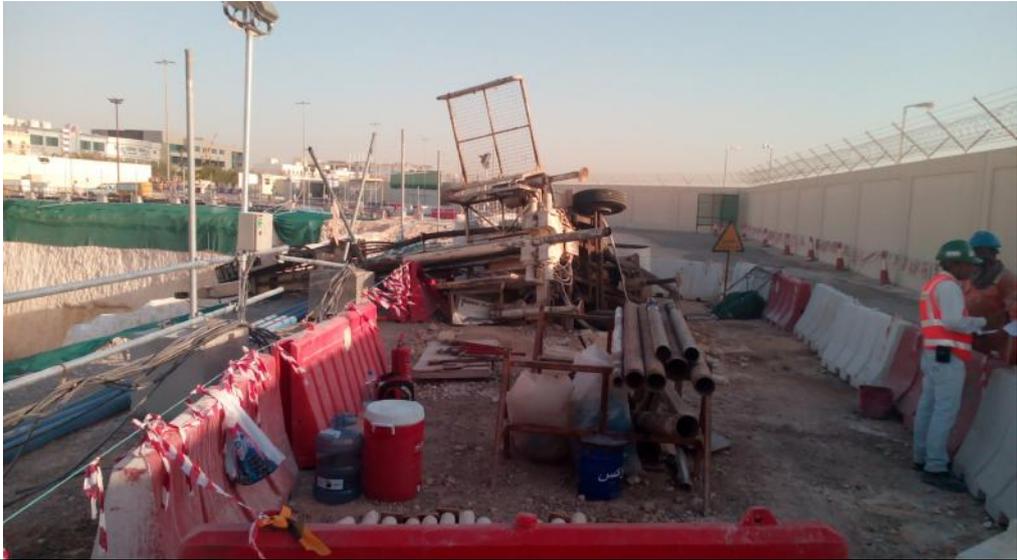
Injuries / Medical treatment required:	No personal injury involved in this incident
Findings:	<p>Due to the borehole being completed the evening before, drill cuttings may have settled within the annulus causing collaring of the drill string which may be the cause of the casing becoming stuck.</p> <p>The incident occurred as a result of driller operating error, failure to follow standard operating procedure</p>
Lessons Learnt:	<p>The drill operator left the F100 drill rig feed lever in the down position, standard operating procedure states that the driller should not leave the controls when rig is in operation.</p> <p>The drill crew were not using the provided clamps to break out the drill rods. If the crew would have used the provided clamps there would be no reason for the driller to leave his control panel.</p>

<p>Recommendations and corrective action:</p>	<p>Safety briefings to all drilling personnel (supervisors, drillers, assistants) about the incident to be carried out. All Fugro Peninsular F100 drill rigs to be fitted with additional emergency stops on the opposite side of the control panel. Issue modified 4 x 4" timber stabilizing pads for drill rig jacks. As part of Safety Briefings and Method Statements, a clearly defined emergency access and egress area around the entire drilling rig of a 2m should be allowed for. The markings on the F100 control panels to be checked and improved where necessary.</p>		
<p>Alert Issued by:</p>	<p>S Brown</p>	<p>Safety Alert Reference No.</p>	<p>FPen-SA-14-01</p>
