HiPo ALERT

14 TONNE TRACKED EXCAVATOR OVERTURNS ON TRAILER RAMP

ON MONDAY 16TH FEBRUARY 2015 AT THE A21 TONBRIDGE TO PEMBURY DUALLING PROJECT, A TRACKED EXCAVATOR SLIPPED OFF A TRACTOR-TRAILER RAMP WHILST BEING LOADED ONTO A FLAT BED TRAILER.

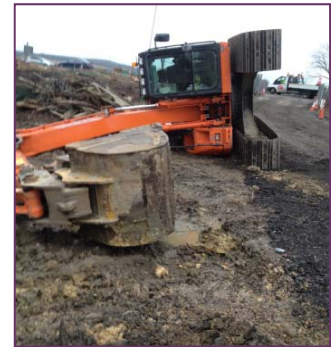
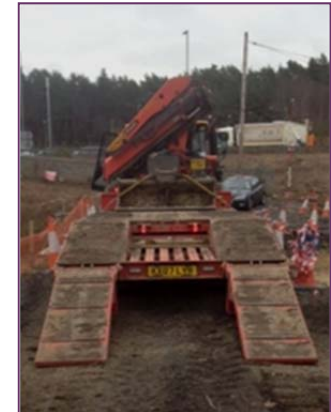
- No grip where metal excavator tracks and metal ramps are used.
- Possible operator error – harsh operation of controls when slewing 180 degrees when positioned at the top of the ramp.
- Operative not following the safe system of work – a spare bucket was within attached bucket.

- Excavator tracks were wet but with minimal mud / planings affixed.
- Tractor-trailer positioned on a slight incline (6-degree slope).
- Counter-balance affected by extra weight within the attached bucket.

- All loading and unloading of mobile plant MUST be completed on flat / level stable ground.
- All ramps, trailers and excavator tracks MUST be clear of excessive mud, foreign objects and debris.
- The surface of trailer's ramps and deck must be protected by wooden and / or, rubber type materials to enhance grip and stability when being accessed. Steel on steel must be avoided.
- All mobile plant operatives MUST be competent, follow their training and comply with site rules i.e. wearing of seat belts, clear safety zones, smooth use of foot and hand controls etc.
- When slewing around, the excavator boom must not be fully extended and tools or equipment should not be loaded in the attached bucket.
