SAFETY ALERT

Date 19-04-16

INCIDENT DETAILS

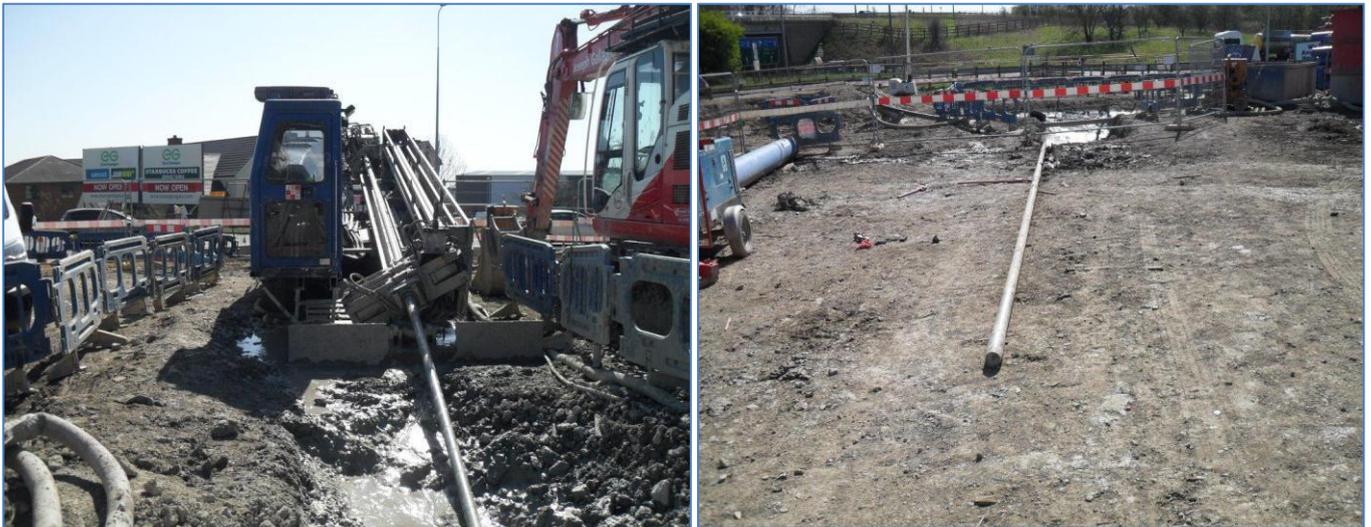
Due to problematic ground conditions the reamer was being reversed out of the bore hole. Drilling rods were being disconnected on the reception pit side by the subcontract operative. As the first rod was pushed through the subcontract operative began the disconnection process. The rig operator then loaded the second rod and proceeded to push the second rod through despite the fact that the operative was still disconnecting the first rod.

To disconnect the first rod the operative had restrained the rods with Stilsons. When the second rod was loaded by the rig operator the turning effect of the rods, coupled with the restraining effect of the disconnection process created stored energy within the rods.

When the energy was released from the rods the operative was thrown into the air and suffered several injuries, including a fractured Fibula to his right leg, a pelvic injury and blow to the head. The injuries are not life threatening and the operative will remain in hospital for 48 hours for observation.

- All site operations halted until a further safe system of work has been established for managing and controlling the rod disconnection process

-
- Revised method statement required to accommodate changing site conditions – to be briefed to all staff
 - Clear communication channels to be established and briefed at the start of each shift
 - If changes are made to working teams, during the shift, teams must be debriefed before commencing any further work activities
 - Review and briefing on the significant elements of the method statement relevant to the day's activities to be undertaken
