# Safety Incident

Portland Park Embankment – LNE Aug 2017

PBS1 2100 137m 70ch

# Level 1: Preliminary Findings

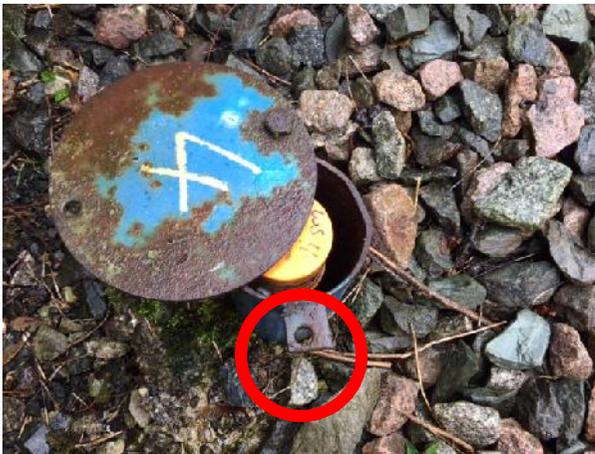
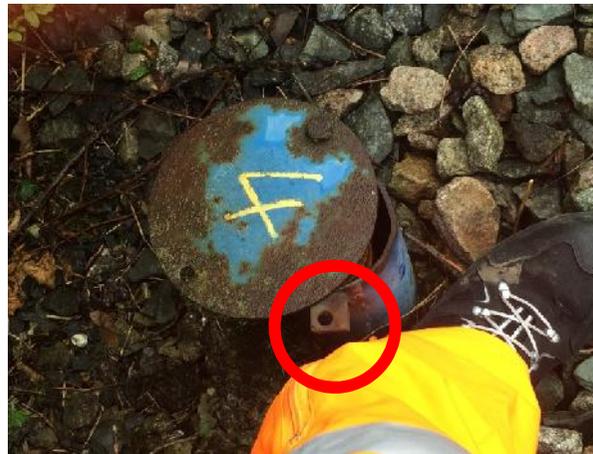
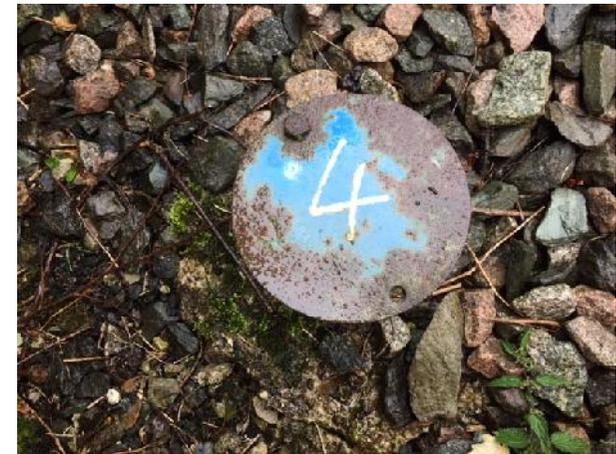
- Incident occurred at approximately 00:20 on Sunday 8<sup>th</sup> August 2017 during a possession. Underfoot conditions were wet during falling rain. Visibility less than 200 yards and lighting was by Head Lamp and Hand Torch.
- Member of staff was placing protection and turned to change direction. This action caused him to lose balance, tripping over the cess rail and stumbling down the upper part of the embankment approximately three to four yards.
- The member of staff made an abrupt contact with part of the steel protection cover (from an earthworks monitoring instrument). This caused a laceration to the top of his left ankle just above the boot line. Operative taken to A&E where morphine was administered and the laceration required 11 stitches. Hospital advised of 10 days rest.

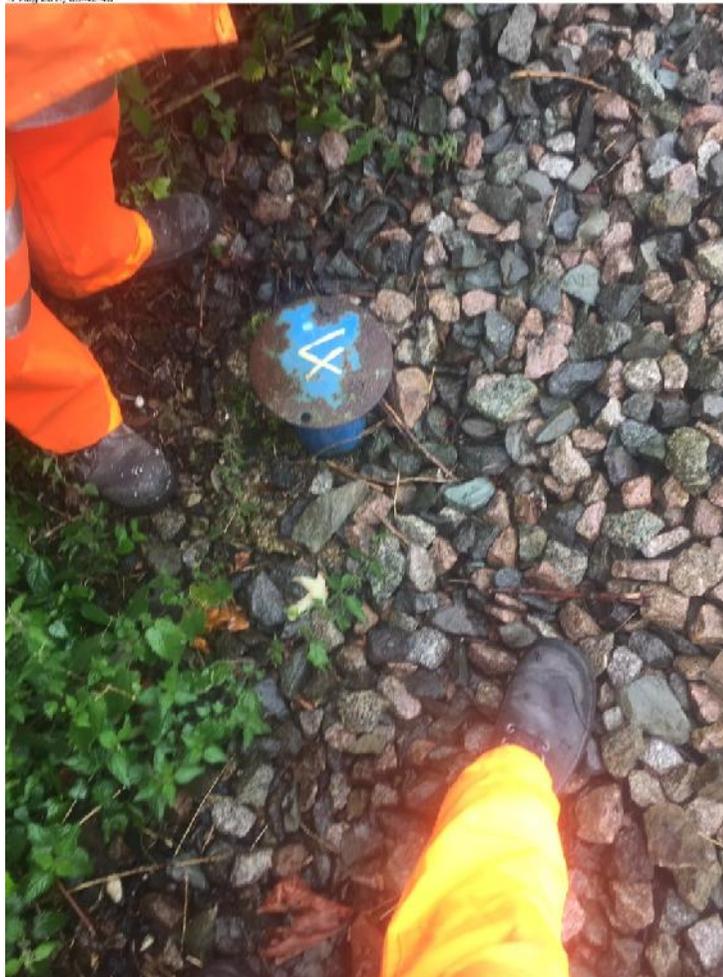
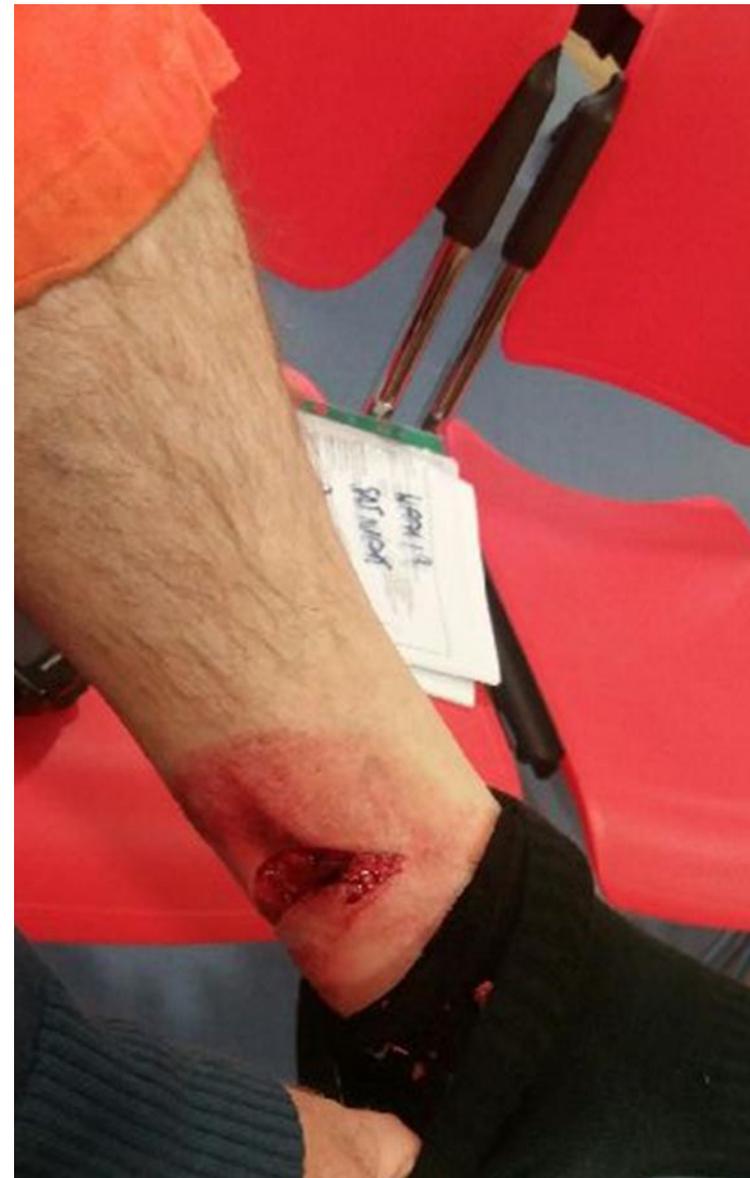
# Sustained Laceration

I- 2560579 53 0806087] Too far from tracks  
17 Aug 2017, 09:42:45

- If the protection helmet was closed properly would it have been more likely that the laceration was instead a severe scratch or bruise?
- Do / Should RAM Geotech Teams see that the hazard directory is updated with information on where these monitoring wells are in existence?

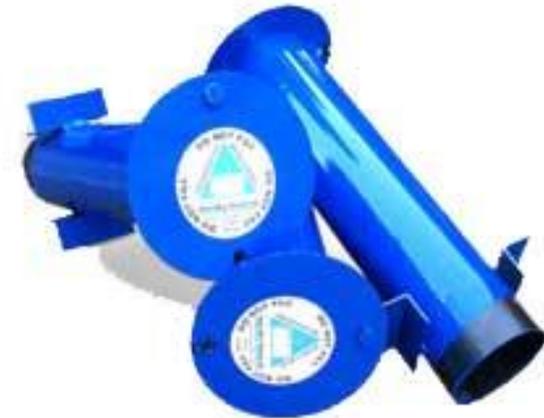
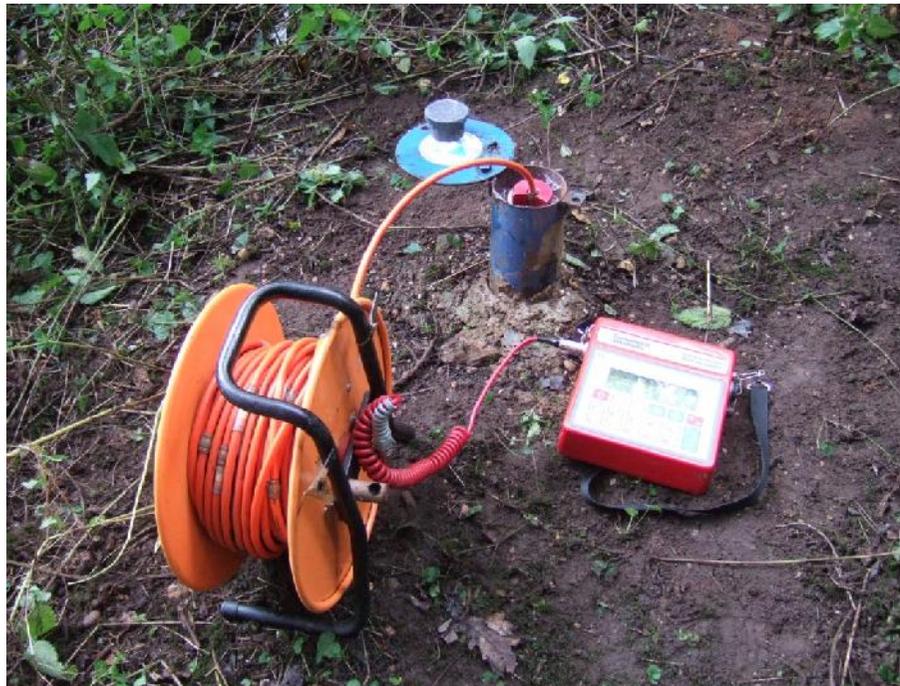
- Borehole covers installed to protect monitoring hole
- Locations are monitored predominately by manual reading of inclinometer torpedo and data logger (see below)
- Made from steel the top cover plate is held by a welded pin and allows rotation through 360-degrees
- Cover is lockable by using a padlock

- Installed at locations where stability may have been a concern to the RAM Geotech
- Sub-surface well is an asset and needs to be protected even if monitoring is not taking place due to lack of movement
- Standard detail in civil engineering design catalogue, concreted into the ground
- Likely to be in excess of 1000 borehole locations with steel helmet cover

- Do RAM Geotech teams have clear monitoring plans that detail how these locations should be left after readings have taken place?
- Should all covers be secured (noting that padlocks often rust shut) to prevent exposure to the locking square in slide 2?

- Should modifications be made to the standard detail?
- What should be done where the top cover plate cannot be closed (i.e. a protruding tube?)
