FEDERATION OF PILING SPECIALISTS SAFETY ALERT

HiPo – near miss

Unstable Piling Rig

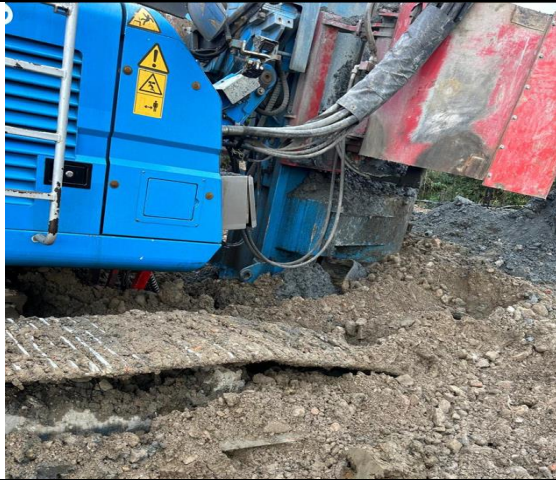
On the day of the incident the site team had just bored a 350mm x 10.5m pile when the concrete pump broke down. Needing to clear the concrete lines the team pulled off the pile and were in the process of tracking back away from the pile when the front of the rig tracks started to sink. Attempts to reverse and then track forward only made the rig sink further. The rig operator lowered the mast foot, and the attendant excavator was used on the rear of the rig to provide additional stability to the machine. Management attended site and the rig was safely recovered to a stable position, where upon an investigation commenced. The Investigation determined that a soft spot was present in 'firm clay' subgrade that had gone unnoticed /un-remediated.

The design assumptions and the design allowed for two assumed subgrade strength values. The PC adopted the stronger value and therefore a reduced platform thickness, but still within the design. A 6F2 fill was to be used but the as used platform material was questionable and likely not to have been as specified. No grading certs were provided. Plate load testing had been carried out and did not show any cause for concern.

Failure to manage the platform installation in accordance with the design

- Soft spot not identified and remediated
- Suspect SF2 material used

Platform was remediated with a lean mix concrete and increased platform thickness, and additional plate load tests were completed.
