MAJOR INJURY

Whilst installing minipiles on a project at London Bridge redevelopment a Bachy Soletanche employee working within our Specialist Geotechnics team sustained a crush injury to his left hand which has resulted in a Major RIDDOR reportable accident

BACCHAT SAFETY ALERT.

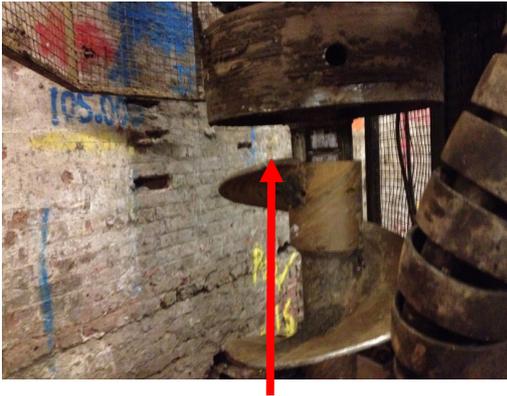
The team were in the process of installing the 9th auger in a sequence of 28. The rig gates were opened and a flight auger had been lifted onto the 8th auger by the rig winch. The pile arising's from the previous flights had not been removed. Once the flight auger was in position the operator lowered the duplex head to engage the 9th auger. The IP climbed onto the pile arising's and waited for the head to fully engage so he could insert a retaining pin to fully secure the auger. At this point there was a breakdown in communication between the rig operator and the spanner man. The rig operator was still in the process of lowering the head however the IP believed that the operation had been completed. The IP had placed his left hand on the top flight of the auger and was bending down in order to locate the retaining pins. The skirt of the duplex head was lowered onto his left hand trapping it between the top flight and the skirt.

The IP was stood directly next to the auger on top of the pile arising in anticipation of the head engaging in order for him to insert the retaining pins. As the duplex head engaged there was no reason for IP to be stood so close to the moving machinery. The rig operator should not have allowed anyone to be stood so close to the moving parts. The working environment inside the guarding and around the casing was not a suitable or stable working platform. The spanner man was required to stand on the pile arising's which were uneven underfoot and also placed his chest, shoulders and head above the connection point. When stood at this point there was a need to bend down or stoop in order to insert the retaining pin. Due to the uneven ground this may have led the IP to place his left hand on the top flight in order to steady himself to enable him to insert the pin.

Hand resting on the top flight as duplex lowered onto the next auger

Following the identification of potential entrapment between the skirt and the flight auger, engineers have re-designed the duplex head. The stem of the head has been lengthened and the skirt has been reduced by 50mm, this completely eliminates the potential of entrapment of hands or other body parts.

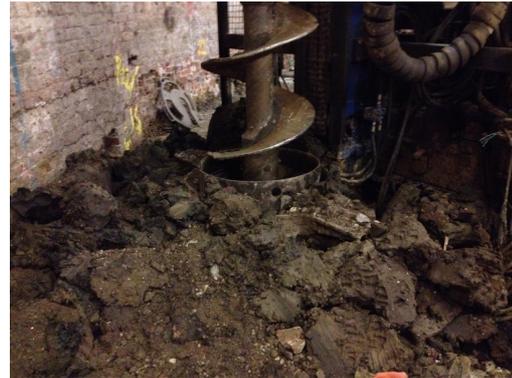
Buildup of spoil leading to uneven ground conditions
