SAFETY ALERT**What happened**

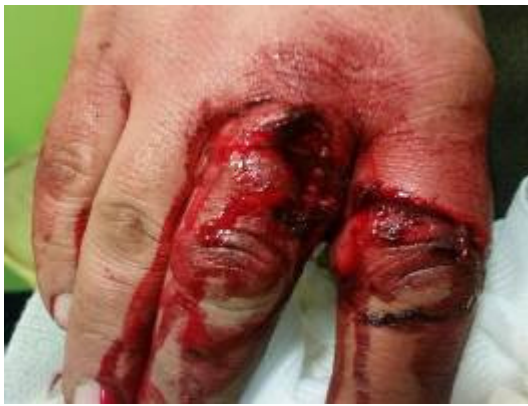
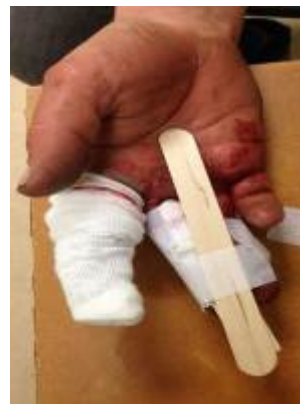
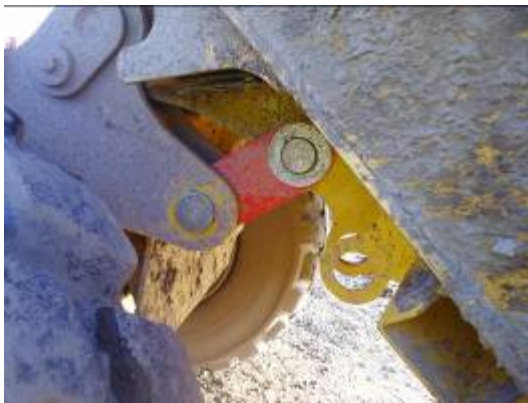
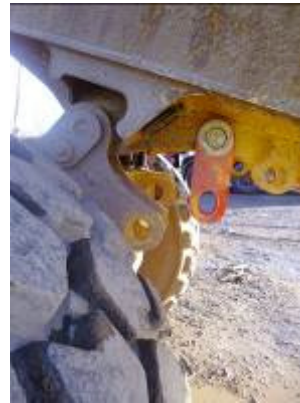
During a routine daily maintenance operation a plant operator needed to access a bank of grease points on an articulated dumper truck that was situated under the skip of the vehicle. To carry out this procedure the operator decided to fully extend the skip to gain better access to the greasing points. In order to do this the skip requires to be locked off to prevent the skip being inadvertently lowered or in the event of hydraulic failure. Whilst attempting to engage the locking mechanism the plant operator found that alignment could not be achieved and this prevented the insertion of the safety pin fully and asked a colleague to drop the skip slightly to try and align the holes. The pressure from the movement of the skip caused the safety pin to eject with enough force to strike the plant operators hand causing serious trauma. This has resulted in hospitalisation and the surgical amputation of his right hand middle finger.

- Review all plant provisions to ensure the safest equipment is in operation.
- Review all vehicles / plant maintenance operations and ensure they are being carried out correctly and all safety devices on any work equipment operate in accordance with the manufactures instructions.
- If the safety device does not function in accordance with the manufacturer's instructions, and prevents the plant / vehicle from working safely, park up your vehicle/plant and report it immediately to your supervisor.
- **Do Not Use** signage must be visibly placed on the vehicle/plant and should also be locked where possible and keys returned to your supervisor pending repair to the safety device.
- Where the design of the vehicle is considered a contributory factor ensure any findings are communicated through to the manufacturer / supplier for their continual improvement.
