## Near Miss Investigation

A medium level near miss investigation has recently been undertaken into a drilling incident. Drilling works using a cable percussion drilling rig were ongoing. The casing was being surged into the ground using a sinker bar, attached to the rig using a lifting eye. Suddenly the sinker bar separated from the swivel.

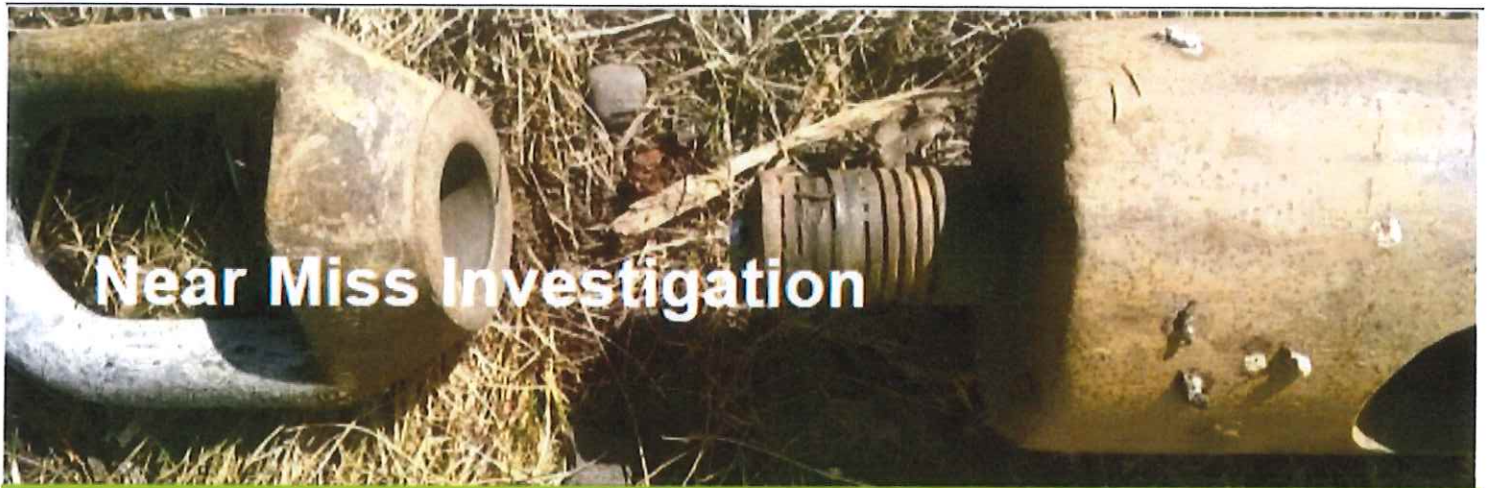
The sinker bar had separated from the swivel as the thread on the lifting eye had failed. The nut and weld were unable to maintain the required integrity. The photograph at the top of this page shows the lifting eye on the sinker bar and the swivel. Further photographs are provided to the right.

The drilling sub-contractor considered that the wear on the thread of the lifting eye was due to poor handling of the swivel, causing a slight deformity in the swivel and resultant wear and tear between the lifting eye and the nut. Ultimately, the thread on the lifting eye and the weld failed.

- Use only fit-for-purpose plant and equipment. Ensure compliance with regulatory requirements (e.g. LOLER, PUWER).
- Ensure that an effective asset management system is in place.
- Make appropriate assurance checks.
- Ensure risk assessments consider foreseeable scenarios and detail control measures.
- Ensure any lessons to be learnt are implemented immediately (e.g. make sure that lifting eyes have appropriate thorough examination).

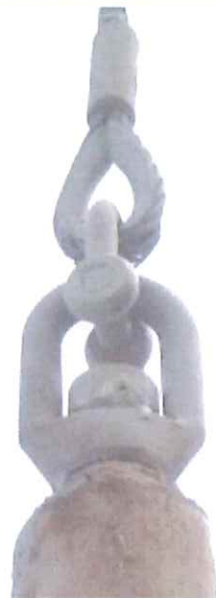
Above: Sinker bar, swivel, shackle and winch cable

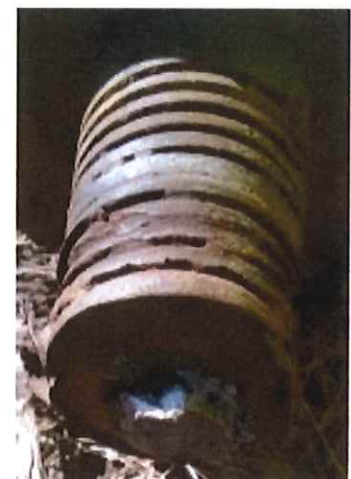
Below: Failed thread on lifting eye
