# Serious Incident – Flying Object

## Incident

**Description:** Whilst drilling a cable percussion hole at the side of the M6 motorway a holding down strap from a lorry ‘flew’ across the M6 Motorway hard shoulder and hit the drilling rig not far away from where drillers and Jacobs personnel were working.

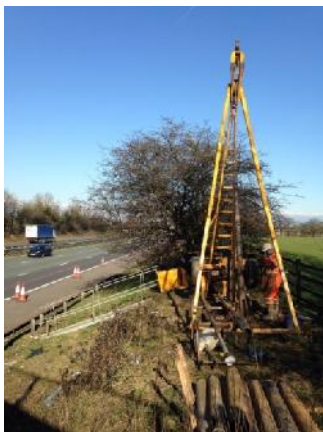
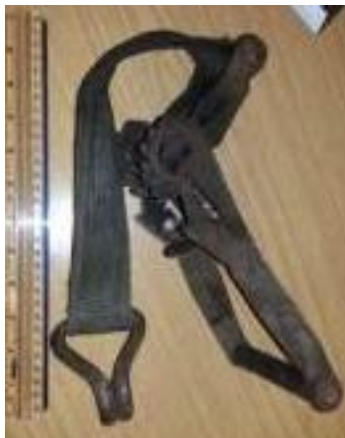
- The rig was on the verge of the hard shoulder.
- Traffic management was in place with the team working with a hard shoulder closure on the verge; team were approximately 4m from live traffic. An Impact Protection Vehicle (IPV) was parked 30m in front of work area offering protection to the work area.
- A change in the layout of the works site was initiated. A van was parked just behind the rig when it was working to act as a screen for objects flying off the motorway.
- The proximity of the team to the live traffic and the high probability of contact with objects falling off vehicles was not fully appreciated when preparing the RAMS.
- The strap had a heavy buckle attached to it which could have caused significant injury if it had hit anyone.

- A stand down held to reflect on current and new practices.
- RAMS have been updated, monthly site safety survey arranged and further reviews of Safe Systems of Work to be undertaken based on findings.

- Work area must be 4m from the back of the hard shoulder with a hard shoulder closure in place. This results in the rig being 2m higher than the motorway carriageway in the sloping grass verge which relates to about 7m away from live traffic.

- Alternatively the work area may be located behind a barrier and in the verge with a hard shoulder closure so that live traffic is at least 4m away from work area. Where this cannot be achieved undertake the work during a nightshift.

- Nightshift working, at least one lane must be closed which results in the work area being over 6m from live traffic. This can only be put in place when the traffic count is less than 40 vehicles / minute, generally about 10.30 pm.

- The site team should “Step Back”, confirm the hazards and reevaluate the risks on site.
