# High Winds – Securing Site Cabins Action Required

## Incident

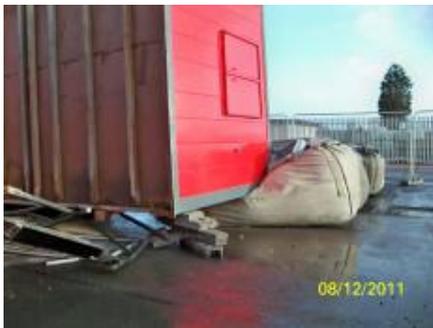
**Photo shows:** Site cabin blown off from lower cabin and resting on 'bean bag safety cushion' at the south-east corner. The site cabin was lifted up by the Contractor's site plant and temporarily propped at the south-west corner. (See over page)

On sites where Jacobs staff have a presence we should, in conjunction with the Contractor, review the processes that have been put in place to ensure that all Site Cabins/ Containers have been adequately constructed and are adequately anchored or secured together to withstand extreme weather conditions.

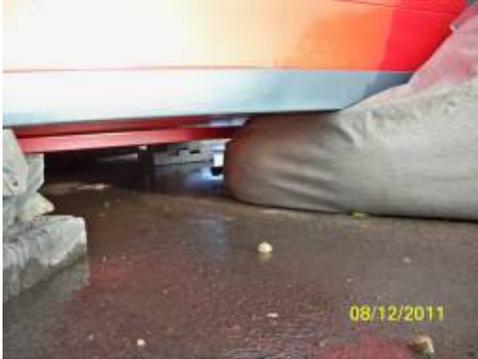
We understand that the Contractor was securing a 'bean bag safety cushion' in a storage area adjacent to the cabins and on hearing a noise he began to run and tripped over, landing on his stomach as the cabin fell to the ground on top of him. Part of the cabin landed on the 'bean bag safety cushion' providing a small void and preventing him from being crushed.

**Photo shows:** View at south-east corner: Site cabin landed on “bean bag safety cushion” and provided approximately 400mm void between the base of the site cabin and the ground level. We understand that the injured party was under the site cabin at this location.

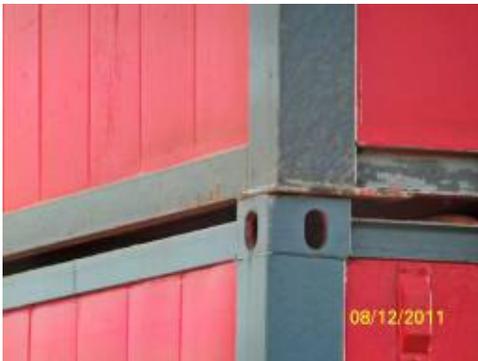
The investigation is on-going, however, it is understood that the cabins were not secured and anchored to the ground. Further details will be issued when they are available.

**Photo shows:** View of remaining cabins immediately after incident – cabins are not physically connected or secured to the ground.
