## Potential Detachment of SPT Swivel / Head Assembly

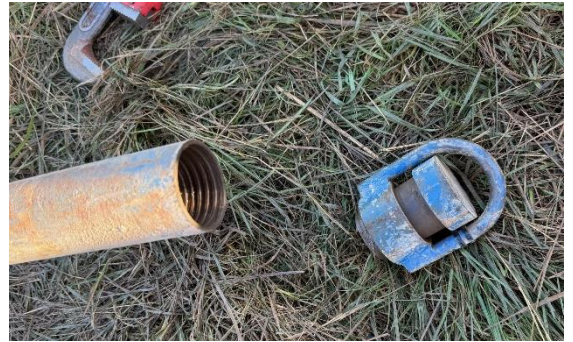
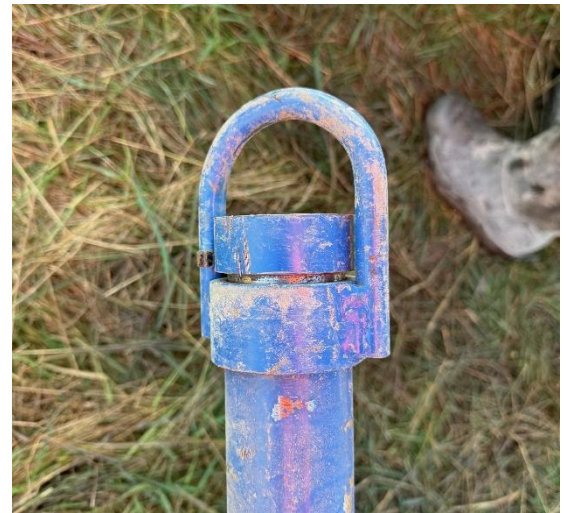
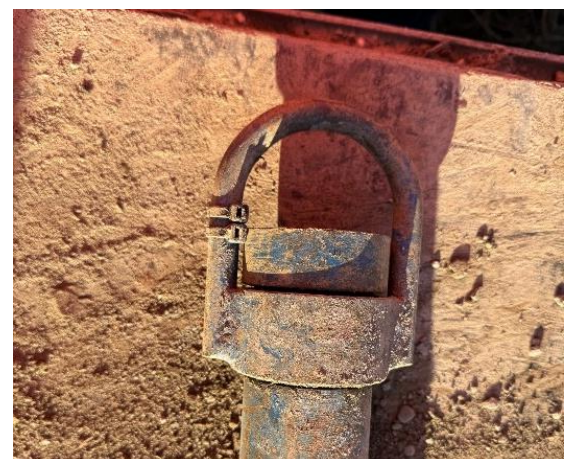
This lifting head/swivel is screwed directly into the top of the sleeve which in turn is attached to a standard automatic drop hammer assembly typically used with a cable percussion drilling machine.

Whilst attaching the SPT assembly, the head/swivel assembly did not turn freely and as the assembly was being screwed to the test string and the head started to unscrew from the sleeve. This could lead to the head becoming completely detached from the sleeve and the whole hammer assembly of approximately 115kg dropping.

The head/swivel design comprises a hook welded to a ring which makes it difficult to observe that the head is unscrewing as the ring obscures the user's view.

- The ring of the swivel can be in contact with the threaded head which can unscrew and detach itself from the sleeve as the swivel turns.
- The thread is too short and does not need many turns to become detached.
- There is no locking mechanism for the head once screwed in.

- Provide a locking mechanism to ensure that the head/swivel assembly cannot unscrew from the sleeve.
- All new plant and equipment, as required by PUWER, must be inspected by the user prior to bringing into operation to ensure that it is safe to use.
- Any safety observations or defects reported by the Lead Driller must be acted on and rectified prior to continuing use.
- Any plant or equipment which has not been rectified must be quarantined and organisations should have a robust procedure in place.
- All lifting accessories, as required by LOLER, must have a unique identifier and SWL marked on them, preferably by the manufacturer, or alternatively by a qualified LOLER examiner.
