PROJECT BULLETIN BUL/015

SAFETY ALERT

On the 5th June 2014 two operatives were operating a Hands England rotary drill rig as part of a ground investigation survey for the Feeder 9 National Grid Gas Transmission River Humber pipeline replacement project.

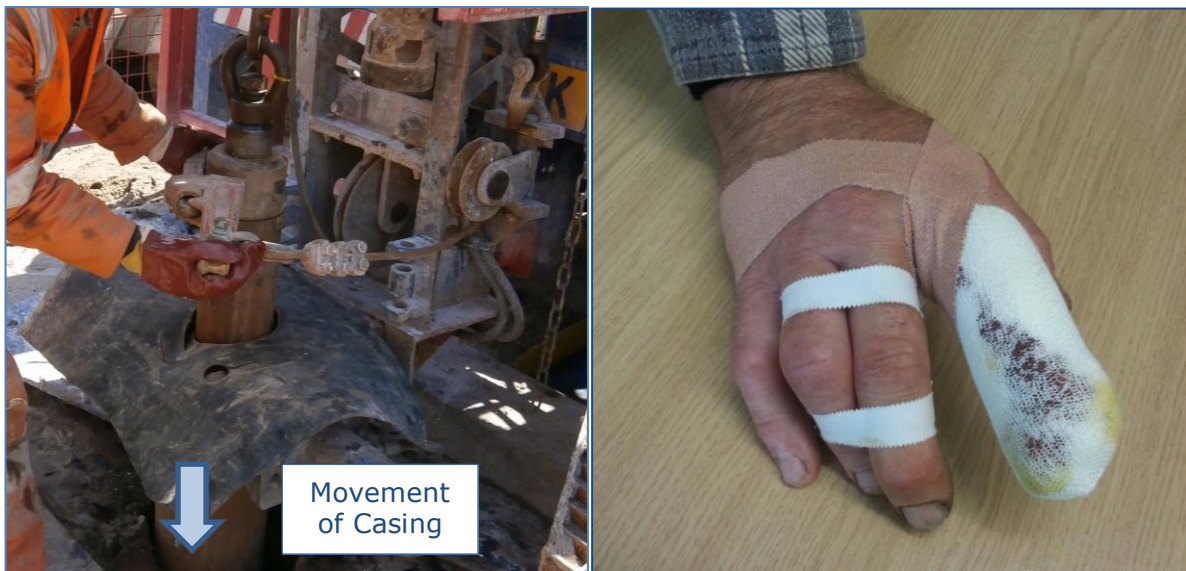
They were removing a Geobore Drive Head using a set of 36" Stilsons attached to a breakout ram. The assistant driller (injured person) was holding the Stilsons in place waiting for the breakout ram to engage. As the breakout ram operated, the casing dropped approximately 6" trapping the injured person's fingers between the Stilsons and the clamp table.

An investigation is on-going to determine the cause of the incident. Initial observations indicate that the casing was not positioned directly in the centre of the clamps and was only supported by the rear clamps. The rig has been placed in quarantine pending the results of the incident investigation.
