Safety Reminder/Alert

Operative Electric Shock

***Issue 14th
February 2012***

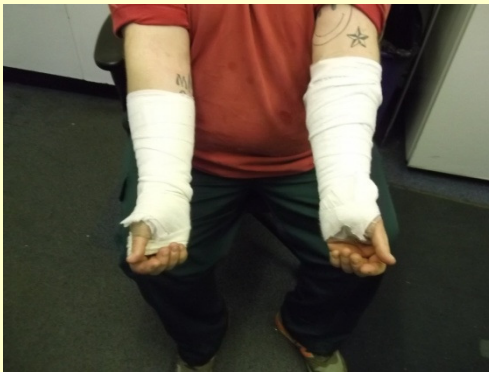
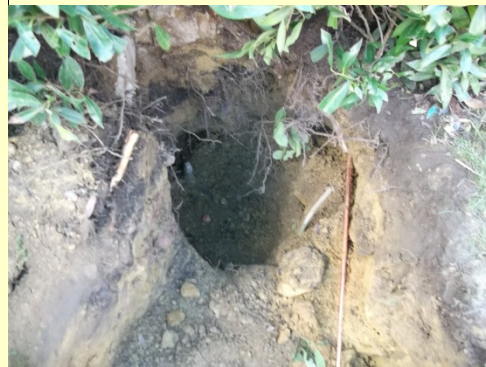
An operative recently sustained superficial burns to his arms, his neck and face from a 415v underground cable whilst working to install a meter to a residential property.

Whilst all the correct procedures had been followed, the RA completed and the service clearly identified to be within the excavation wall but not exposed, the condition of the cable was unknown. During the installation process the operative was required to exert bodily pressure on the sidewall containing the service causing the aged cable to fail at the junction box. The resulting discharge entered the right forearm of the operative earthing through his body via his left forearm.

The asset provider was noted to be in the area undertaking a replacement scheme to aged cabling, however this was not considered as part of the RA.

Meter works to this location have been ceased and are being monitored, however all operatives are reminded to consider the potential risks and question the relevance of other asset providers operations in your proposed works vicinity. If in doubt consult your Supervisor and or DSA before proceeding further.
